HISTORIC PRESERVATION

Choir in War-Damaged French Church Restored As 'Chapel of Light'

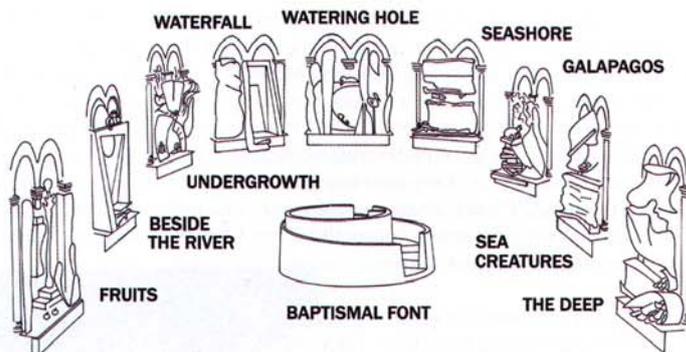
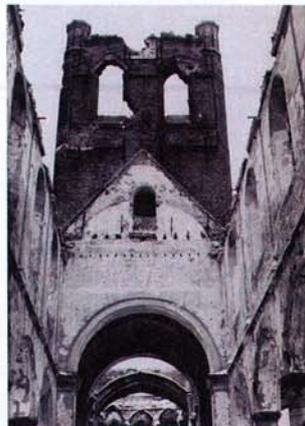
A military aircraft crashed into the church in 1940 and set the roof on fire, left. Later, parts of the building collapsed and the German army removed the stone floor tiles. Other portions of the church were restored after the war, but the more heavily damaged choir was simply bricked off from the nave and abandoned. The restored choir will now support the weight of 13 massive sculptures and a new baptismal font, all designed by the British artist Anthony Caro.

THE CHOIR of a medieval church in northern France that was damaged during World War II and remained closed for more than 60 years has now been restored and its floor structurally reinforced to support the weight of 13 massive sculptures and a new baptismal font, all designed by the British artist Anthony Caro. The Église de Saint-Jean-Baptiste, a Romanesque abbey church in the small town of Bourbourg, approximately 19 km east of Calais, is a mostly stone structure that largely dates to the 13th century, although some portions are older. Designated a French national heritage site in 1920, the Gothic choir section was heavily damaged in 1940 when a military aircraft crashed into the church and set the roof on fire. Later, parts of the building collapsed and the German army removed the stone floor tiles.

Although other portions of the church were restored after the war, the more heavily damaged choir was simply bricked off from the nave and abandoned. The choir

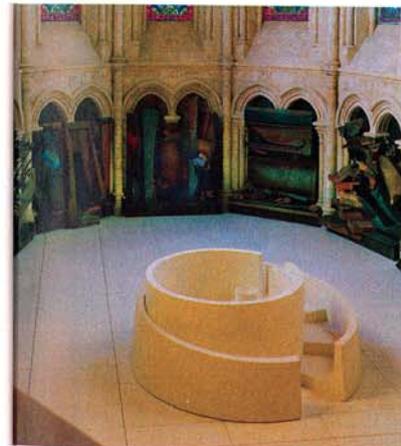
Anthony Caro created a spiraling white concrete baptismal font 3.3 m in diameter that rises 1.25 m from the choir's new floor.

tismal font close to the center of the space that is 3.3 m in diameter and rises 1.25 m from the choir's new floor. Four other sculptures were designed for the choir, including two oak towers 5.2 and 5.3 m tall that engage a series of stone columns located west of the font. The remaining two sculptures are located between the towers and the
